DYNAMIC SCIENCE, INC.
In-Depth Accident Investigation

Contract DTNH22-94-A-07049
Case DSI-96-SB-02

TECHNICAL SUMMARY

This case was selected due to a nylon coat drawstring becoming entrapped in a school bus hand rail and the wearer being dragged and run over by the school bus.

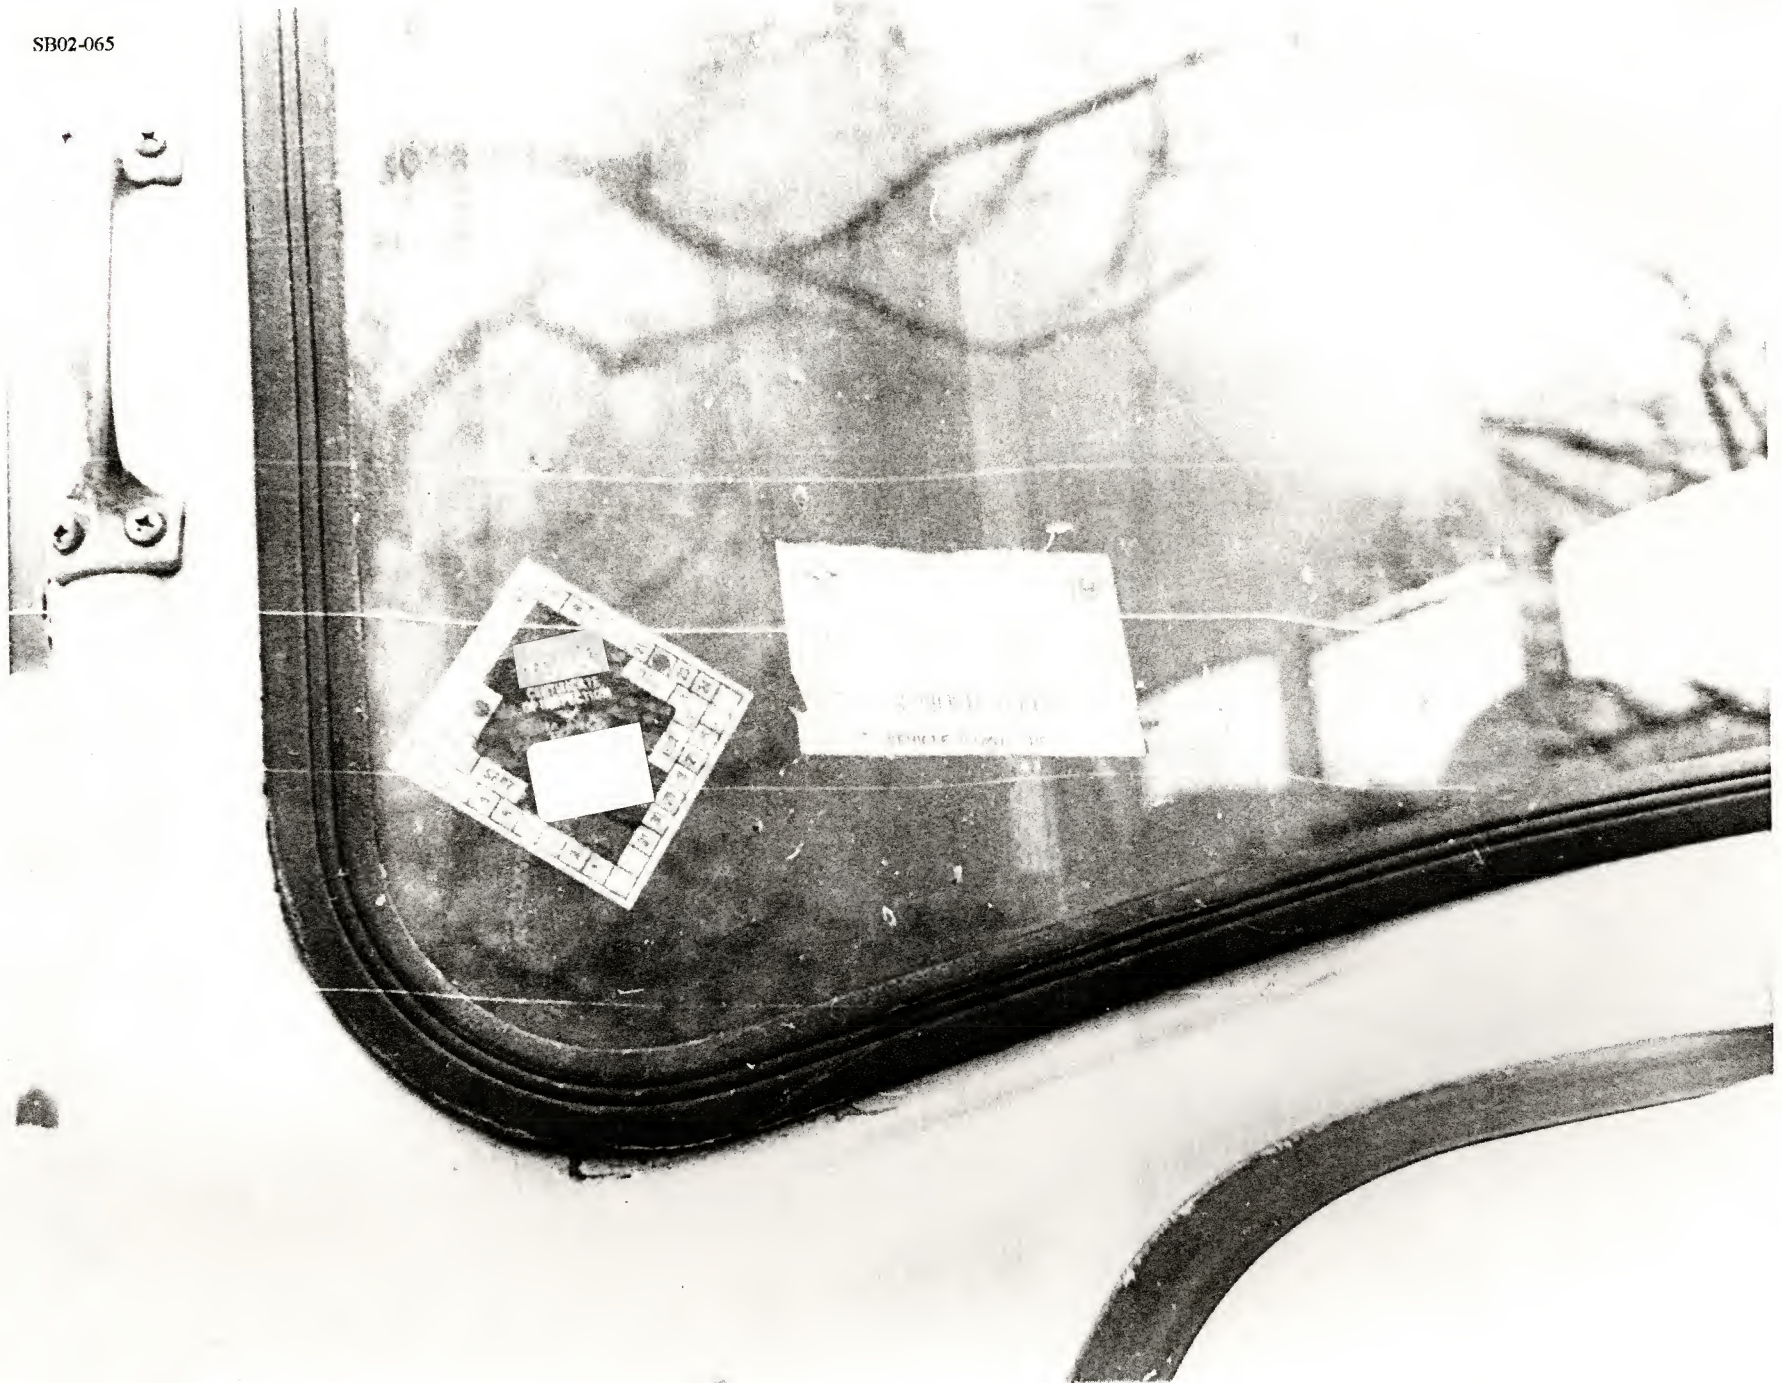
SB02-065

PHOTO NO.	SUBJECT MATTER
60-61	Scene - FRP, books and notebook - case subject
62-63	Vehicle 1, possible pedestrian contacts
63	Vehicle 1, right rear dual wheel
65	Vehicle 1, R/F windshield, Vehicle inspection and registration decals
68	Vehicle 1, stepwell, grab rail and modesty panel
67	Case subject's notebook with abrasion and tread mark
68	Jeans worn by case subject
69	Case subject's coat - front view
70	Case subject's coat - label
71-72	Case subject's coat - back view
73	Case subject's coat - drawstring pucker, back view
74	Case subject's coat - drawstring, right side
75-76	Case subject's coat - drawstring and drawstring end bead
